MANITOBA HYDRO ACCOMMODATES OSPREY ACTIVITY

DAVID C. VANDERBURGH, 125 Dunfield Ave., Dauphin, Manitoba R7N 0P1

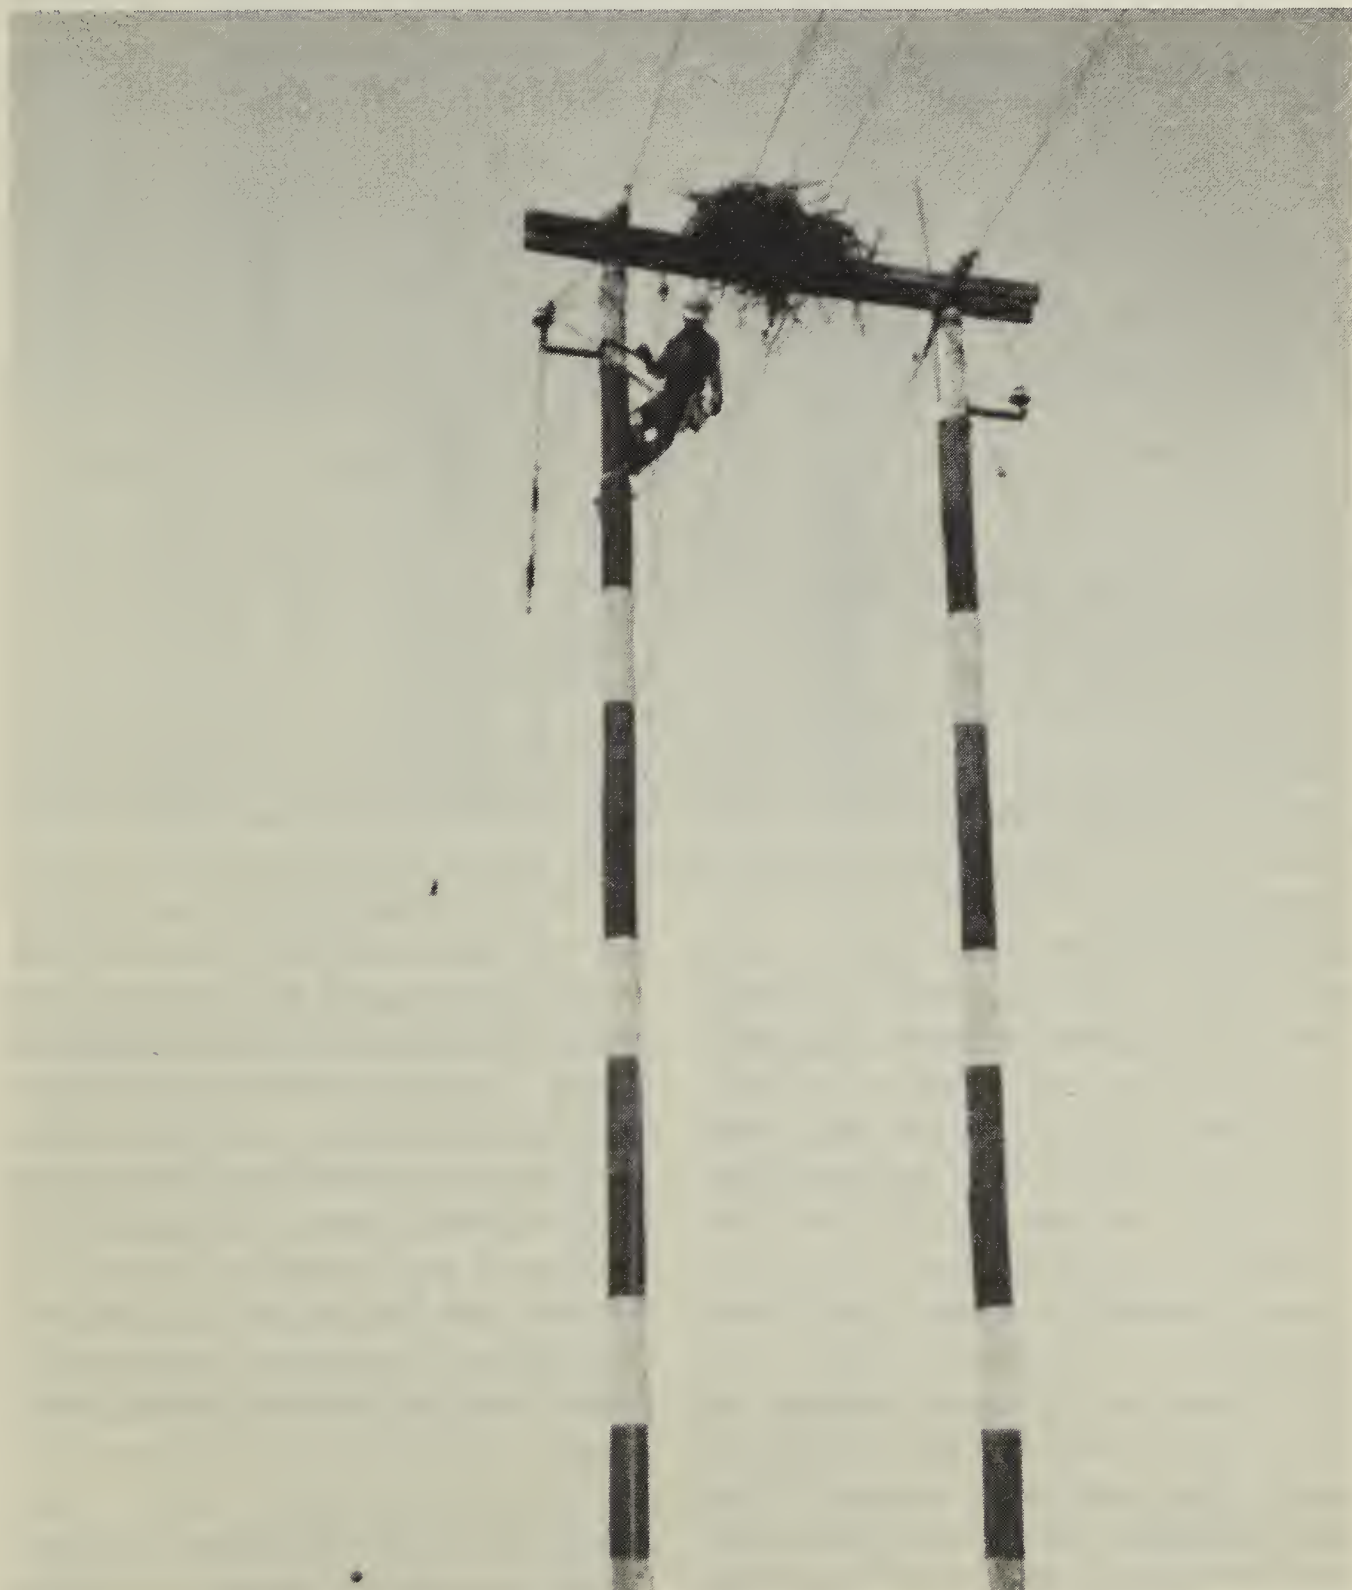
Manitoba Hydro crew remove Osprey nest from power pole.

The Osprey habit of carrying long, wet sticks to the top of hydro structures has caused lines to trip out and even set fire to the tops of the structures. The potential for injury to the birds themselves is, of course, very high. Ste. Rose du Lac operating staff first addressed this problem with an innovative solution in 1988. An Osprey nest with three eggs had been built directly over an energized conductor on the 25,000-volt line crossing the Waterhen River between Waterhen Lake and Lake Manitoba at SW28-32-15W. The nest was in imminent danger of shorting out the line and probably injuring the adult birds as well. The easy solution would have been to simply dislodge the nest from the structure. However, Barry Paradis

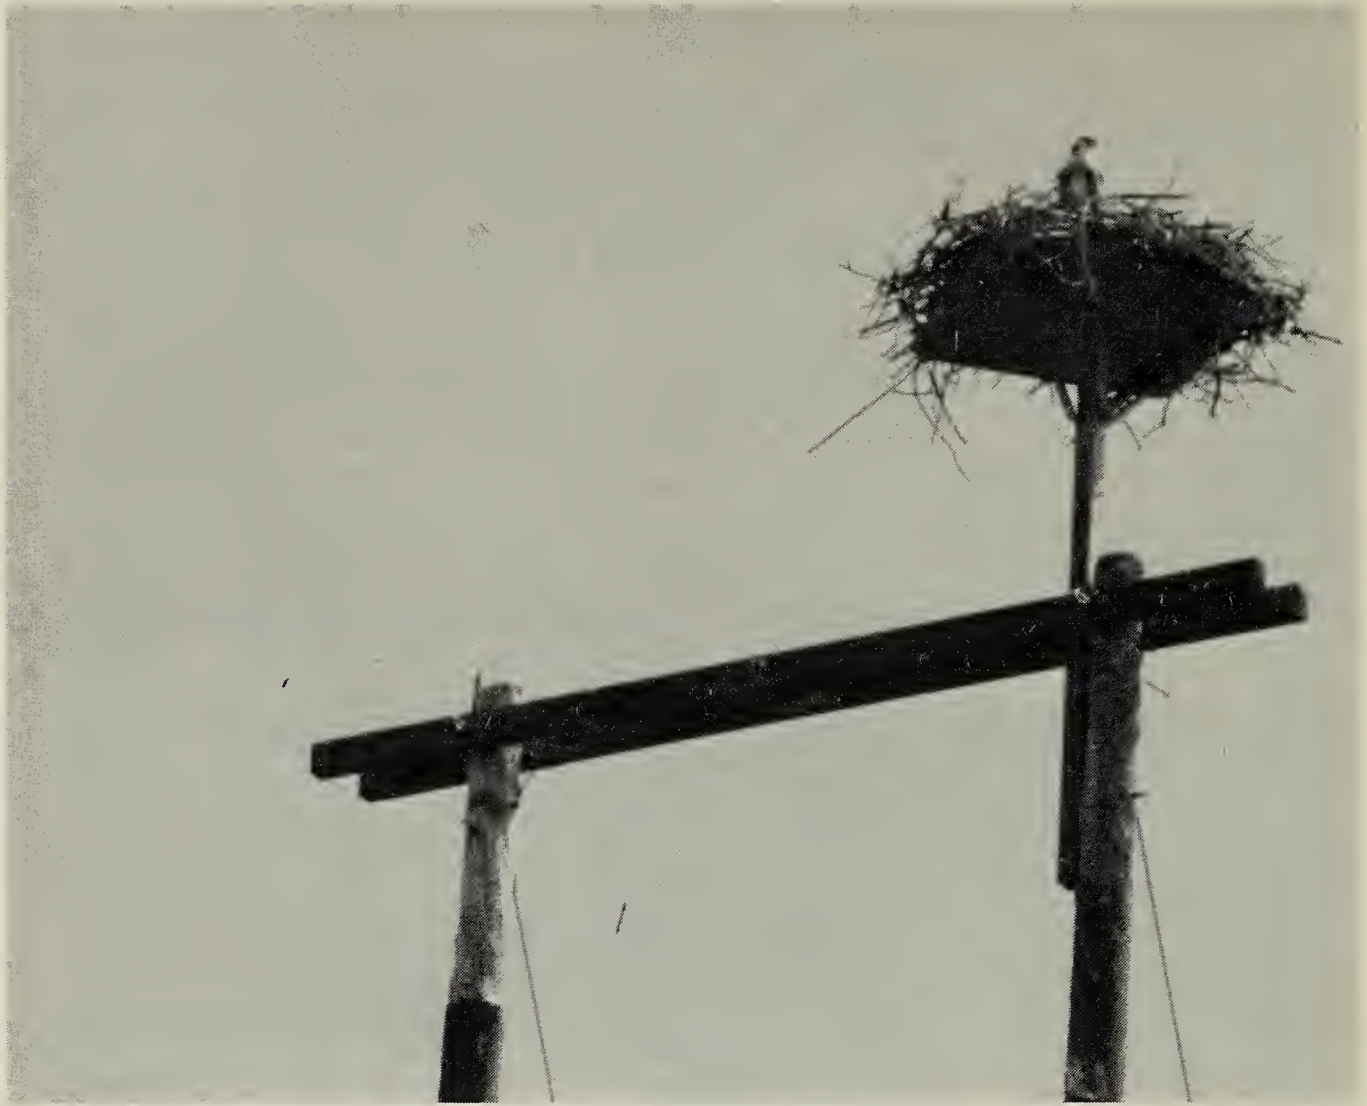
New location of Osprey nest on structure above live power lines.

They contrived an artificial nesting platform from plywood and a cross arm, and, with both men up in the structure, were able to actually transfer the nest and eggs to this platform. They raised the platform well above the conductors and bolted it in place. The adult birds accepted their new quarters and went on to successfully rear three young that year. This success was monitored and confirmed by Cameron Peterson of the Natural Resources Department. The platform has been in place since 1988 and has been occupied every year.

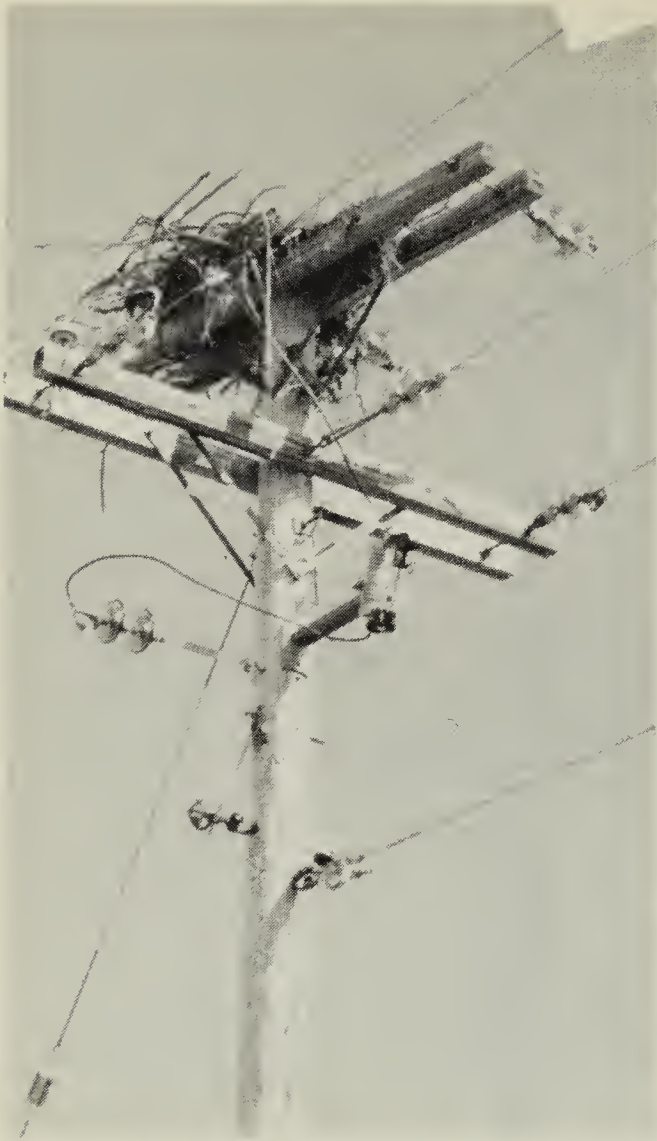
Partially constructed nest on unsuitable corner pole.

Another Osprey event occurred on the west shore of Lake Manitoba SW6-32-15W in the spring of 1991. A pair attempted to build a nest on a 25,000-volt power line corner pole. Because of the unsuitability of this particular pole, Murray Makinson, Ste. Rose district operator, and I conferred and agreed that the partially constructed nest must be removed. This was done twice as the birds immediately tried to re-establish. This same scenario was repeated in the spring of 1992 as another attempt to nest was made at that time. In all three cases, no eggs were involved. Following this last attempt, I arranged for a special pole with a nesting platform to be installed beside this unsuitable corner pole, hoping the birds would attempt to nest there the following spring.

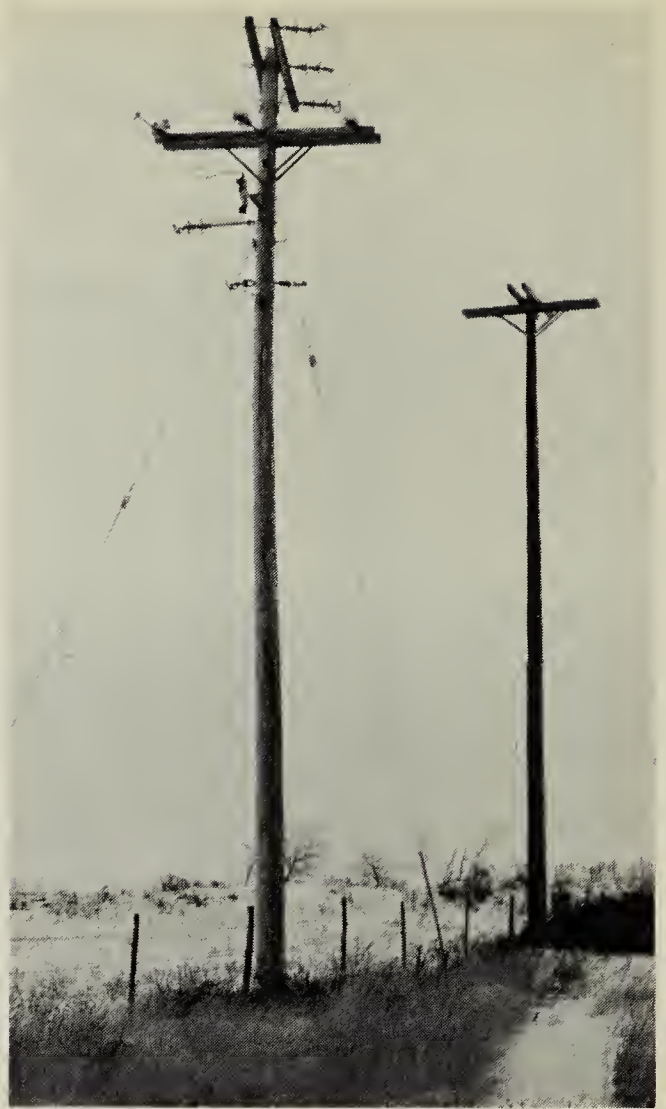
Special "nesting pole" installed to attract Ospreys away from 25,000-volt corner pole.
