THE FIRST USE OF PURPOSE-BUILT ARTIFICIAL CHIMNEY SWIFT HABITAT IN MANITOBA

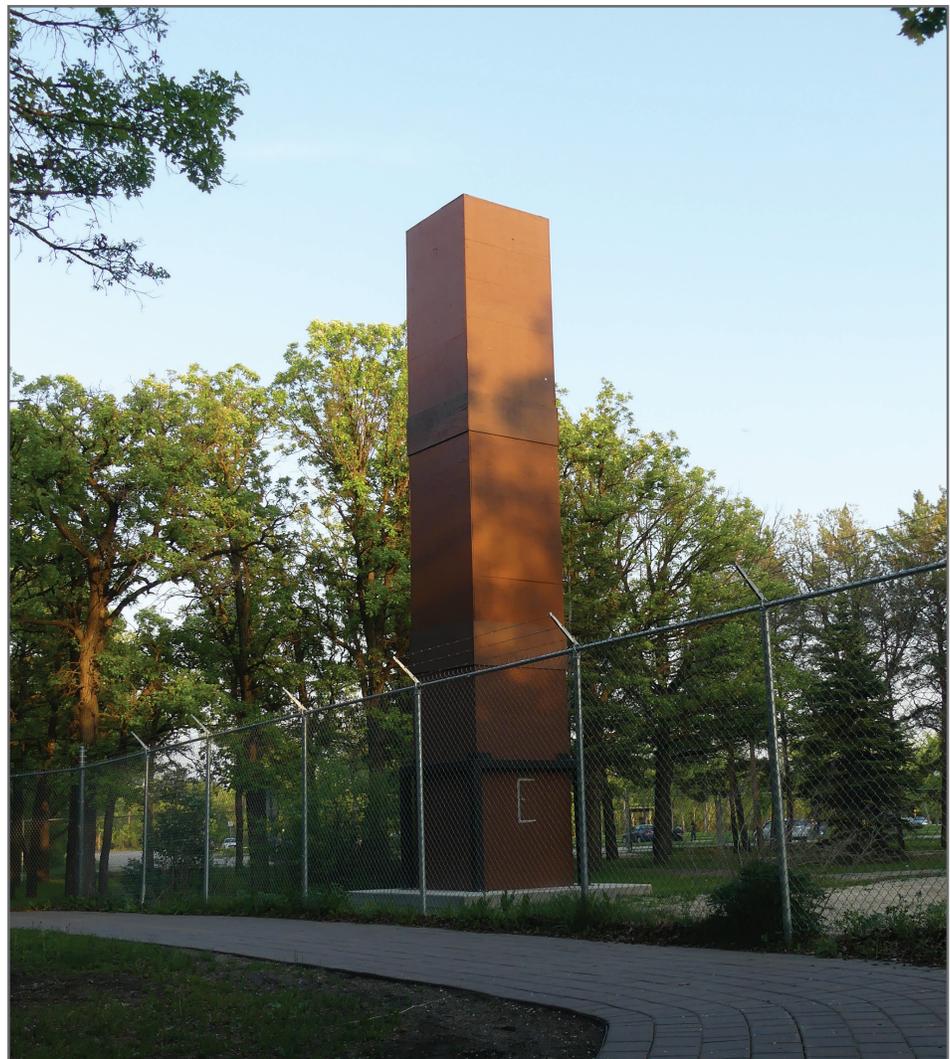
FIGURE 1. The tower in its current location at Assiniboine Park Zoo. Note the three distinct sections, the supportive bracket around the base and the concrete pad. Photo credit: T. Poole.

The tower was reconstructed in spring 2018 before the expected date when Chimney Swifts return to Manitoba (Figure 1). The tower was monitored from late May to mid-August by MCSI volunteers and Zoo staff. While no occupancy was detected in 2018, on 27 May 2018 a pair of Chimney Swifts were observed flying above the tower while 'V-ing' (T. Poole, unpublished data). 'V-ing' is thought to indicate pair bonding and involves the wings snapping upwards at an acute angle.^{1,9} Although no swifts were

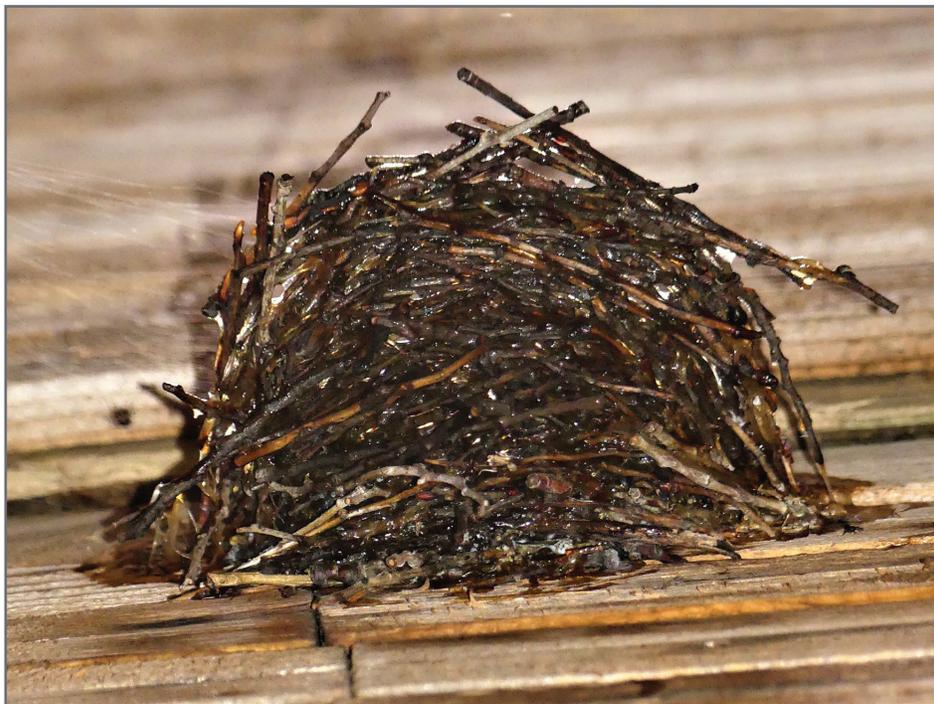
FIGURE 3. Nest on the wall of the tower, taken from underneath in September 2019. Photo credit: T. Poole.

An inspection of the interior of the tower in September 2019 revealed that three, possibly four eggs hatched inside the tower. There was also a single unhatched egg and the carcass of a deceased adult bird. An inspection of the wall revealed that a nest had been constructed below the lip where the bottom section of the tower connects to the middle section, at a height of approximately 3.6 m from the base of the tower (Figure 3). Zoo staff retrieved the nest from the tower during the winter of 2020. The nest was empty, confirming that a minimum of three chicks fledged during the summer of 2019.
