POSSIBLE EFFECTS OF PLACEMENT TIMING ON THE USE OF REPLACEMENT HABITAT BY CHIMNEY SWIFTS IN MANITOBA

Timothy F. Poole

Manitoba Natural Resources and Northern Development
200 Saulteaux Crescent
Winnipeg, MB R3J 3W3
timothy.poole@gov.mb.ca

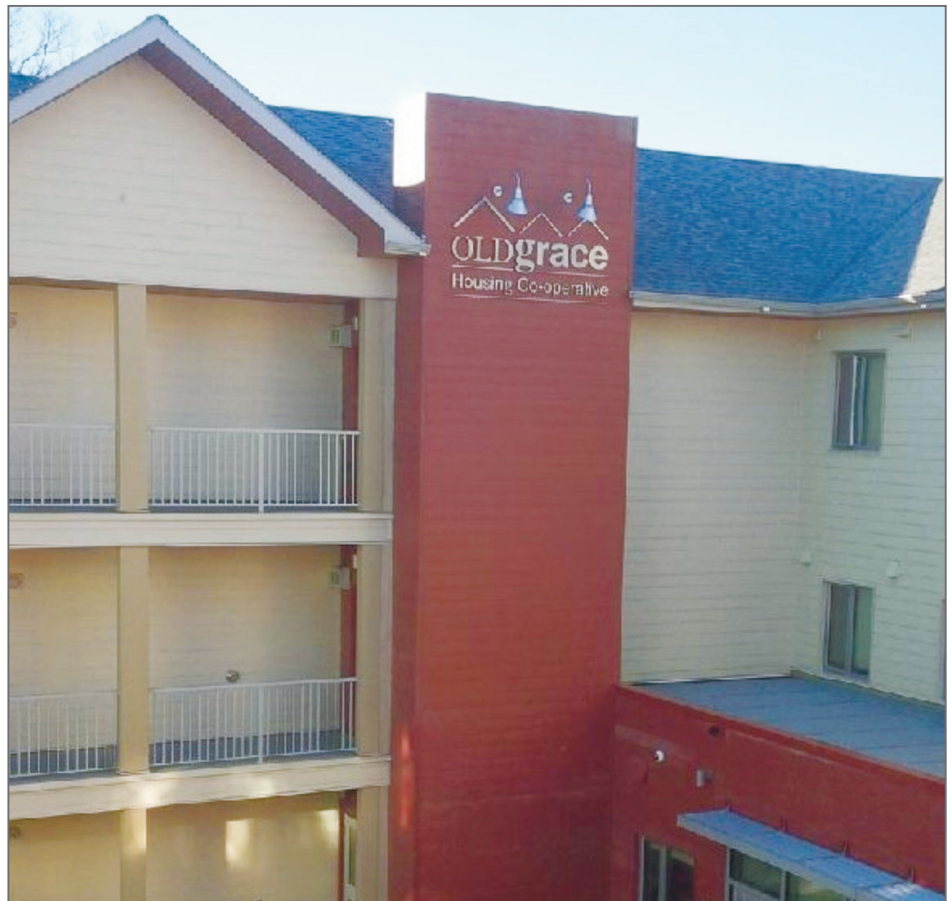
FIGURE 1: False chimney at the Old Grace Housing Cooperative. Note that the chimney is the large red rectangular structure in the centre of the photograph. Photo credit: Ken De Smet, Manitoba Government.

a rain shield. These dimensions were equivalent to, or exceeded, minimum dimensions of chimneys that are used successfully by Chimney Swifts in Manitoba.⁶ The chimney was designed specifically to occupy an area of wall as part of the overall site development plan (Figure 1).

The false chimney was completed in 2018, but upon closer inspection it was found that horizontal metal support bars remained inside the chimney during the breeding season. These were removed by spring 2019 and the chimney is now considered to be suitable for Chimney Swifts. There was, however a four-year gap in habitat availability at this site. Prior to 2021, no Chimney Swifts were observed using the Old Grace Housing Cooperative site during nest and roost monitoring, which covered a period 60 minutes before and 30 minutes after sundown.⁷

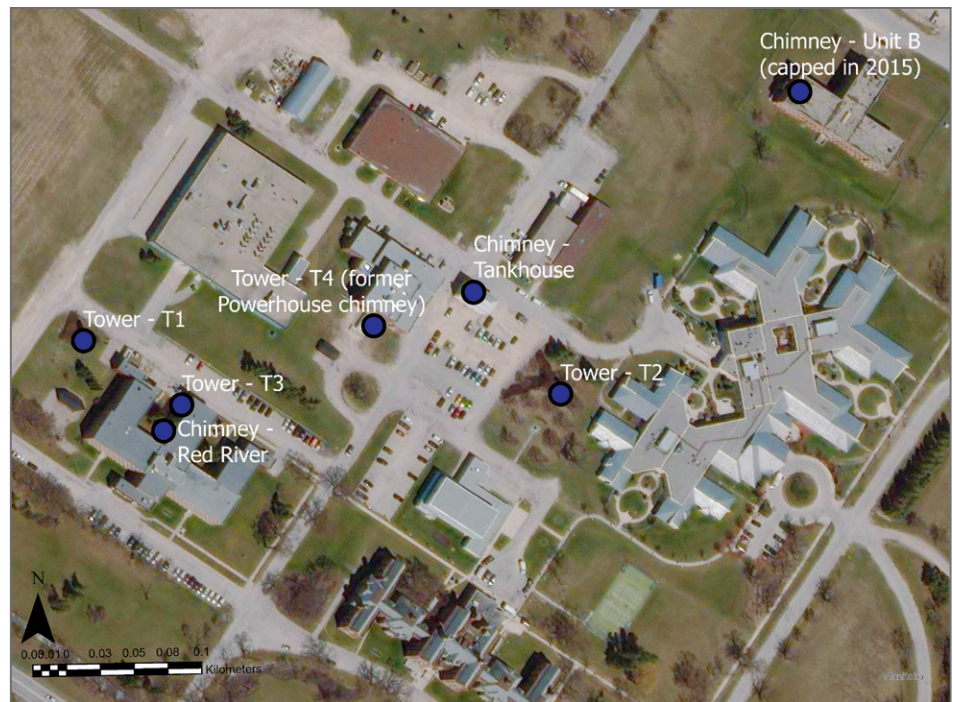
FIGURE 2: Plan of all chimneys at the Selkirk Mental Health Centre. Map created on ArcGIS Professional and property of the Government of Manitoba.

Three chimneys have either been demolished or capped, or are to be demolished in the near future, at the provincially owned Selkirk Mental Health Centre in Selkirk, Manitoba. Four artificial towers were constructed at this location in spring and summer 2021, which were part of a mitigation plan in lieu of the destruction of three buildings with chimneys used by Chimney Swifts on the site (Figure 2).⁸

A known nesting chimney on the Unit B building was capped in fall 2015 as there was a possibility of imminent demolition. A second chimney, the 36.6 m (120 foot) tall Powerhouse stack chimney, was demolished in April 2021. Since monitoring began in 2007, this chimney was a significant roost site, supporting up to 61 Chimney Swifts on a single night (Manitoba Chimney Swift Initiative, unpublished data). The Tankhouse and its chimney is to be demolished, but was still standing in April 2022. There are no plans to demolish the Red River College building that also supports a nesting chimney. The letter of exemption and federal permit allows for the destruction of all three buildings and the subsequent construction of six replacement artificial towers.⁸ Three replacements, two free-standing towers (T1 and T2 in Figure 2), and one tower attached to an existing

building (T3 in Figure 2) were constructed before 1 May 2021. The fourth tower (T4 in Figure 2; Figure 3) was completed in mid-June 2021 and built on the site of the Powerhouse chimney. All tower designs and construction were based on the successful tower at the Assiniboine Park (former Old Grace tower), the design of which followed guidelines from the Manitoba Chimney Swift Initiative.^{5,6} Internal dimensions of T2, T3 and T4 are 0.762 m x 0.762 m x 10.36 m; T1 is 0.76 m x 0.76 m x 13.82 m. The inside of each tower is lined with rough sawn cedar and the outside is clad with steel sheeting.

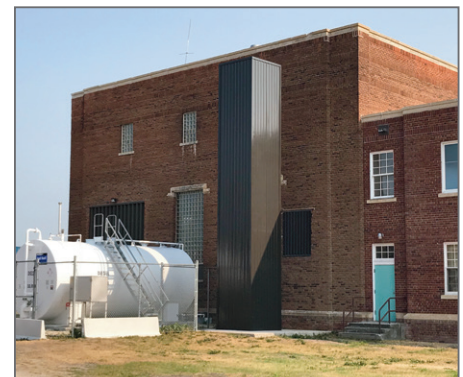
FIGURE 3: Tower T4 at the Selkirk Mental Health Centre. Photo credit: Robert Stewart.

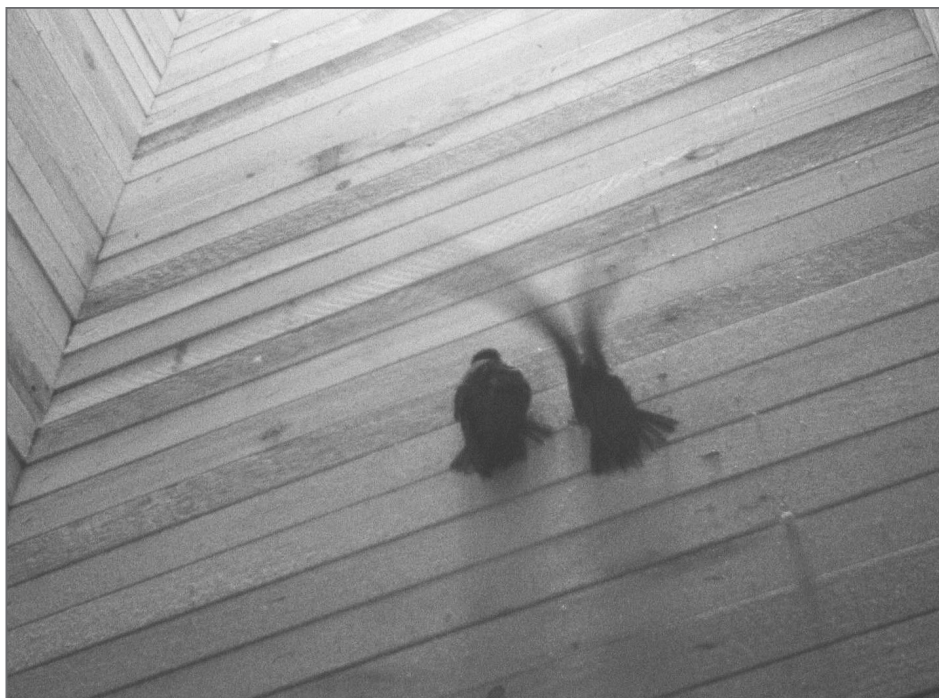
FIGURE 4: Motion capture image of a pair of Chimney Swifts inside T2 taken at 10:14:37 on 8 June 2021. Photo taken with Reconyx Hyperfire 2 camera and property of the Government of Manitoba.

T2: First monitored on 11 May 2021. First use by a single roosting Chimney Swift during playback on 18 May 2021 and subsequently on 24 May 2021. No Chimney Swifts roosted on 26 May and 3 June 2021, but two roosted on 7 June 2021. Images from the Reconyx Hyperfire 2 camera indicated that a pair was present together in the tower during the day on 8 June 2021 from 10:14 to 10:16 (Figure 4). An entry/exit cycle observed from outside the tower during the day on 10 June 2021 suggested possible nest

building.¹⁴ A presumed pair, based on two individuals in the tower together, roosted on the same evening and on 15 June 2021. Further use of the tower was recorded by the Reconyx camera between 19 and 21 June 2021, but no further use was recorded after this either by volunteers or the camera. Contrary to observations on 8 June 2021, no evidence of a nesting attempt was found inside the tower when it was inspected on 10 September 2021, although droppings confirmed that birds had used it earlier in the season.

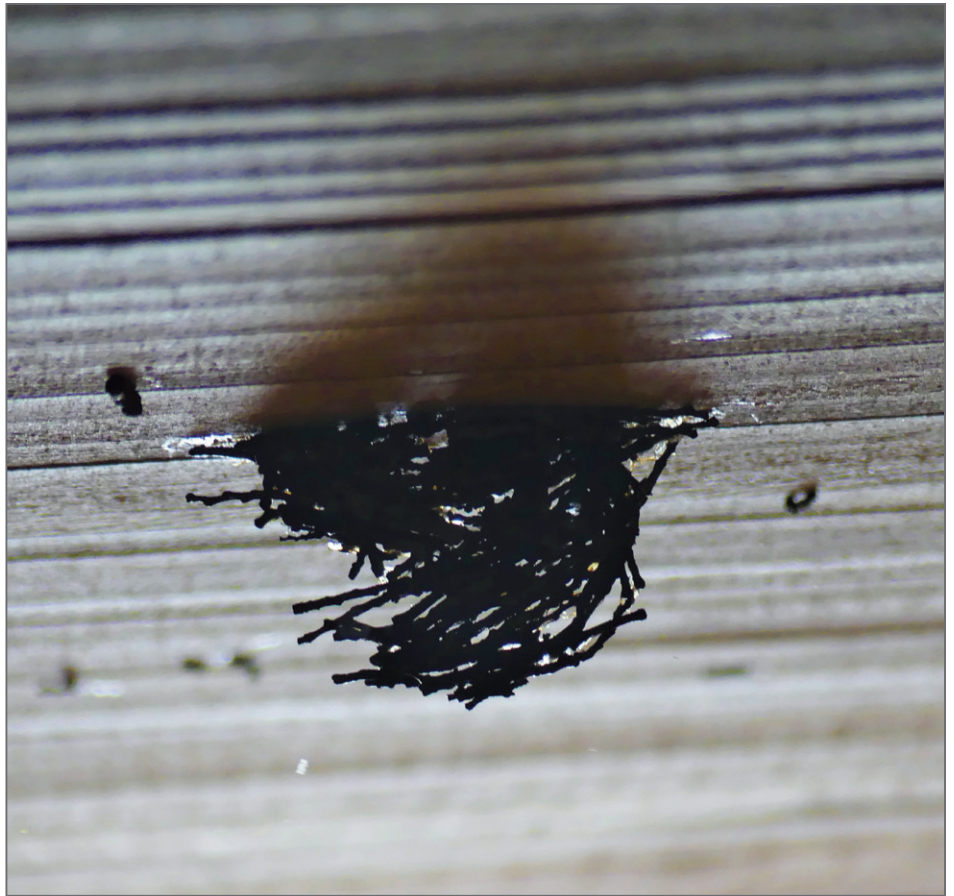
FIGURE 5: Nest on the wall of tower T4 at the Selkirk Mental Health Centre taken from underneath on 23 September 2021. Photo credit: Timothy Poole, Manitoba Government.

T4: Observations first made on 18 June 2021, while construction workers were still working on the side of the tower, noted three Chimney Swifts regularly flying over the rim during the daytime. A single Chimney Swift roosted inside the tower on 23 June 2021, the first monitoring night post construction. Two birds roosted on 27 June and 7 July 2021, but no birds were noted roosting inside the tower on 15 July 2021. A single Chimney Swift was observed entering the tower on 15 July 2021 at the culmination of a 90-minute daytime monitoring session. Monitoring was not conducted consistently at this site again until 11 August 2021 when six entries and four exits were noted during monitoring and two Chimney Swifts roosted for the night. A similar level of activity was detected during roost monitoring on 16 August 2021. On 19 August 2021, a probable nesting attempt at the non-brooded juvenile stage was confirmed during a 90-minute daytime observation period.¹³ Further monitoring indicated nesting was being attempted, culminating in two fledged juveniles entering the tower on 9 September 2021. Observations continued until no Chimney Swifts were observed using the tower, with the final monitoring session occurring on 15 September 2021. Evidence of nesting Chimney Swifts was found upon inspection of the cleanout trap on 23 September 2021, including a nest on the wall of the tower (Figure 5), eggshells, twigs and droppings. No carcasses were present on the floor of the tower. The mass of eggshells suggested that three or four chicks hatched in this tower but confirmation of total productivity cannot occur until the nest contents can be examined for dead chicks.

July 2021 was likely an adult carrying nesting material. Assuming it takes a minimum of seven days to build a nest and lay the first egg, incubation may have started on 21 July 2021 and hatching may have occurred between seven and 10 August 2021. No birds were detected using the tower during monitoring of the adjacent Tankhouse chimney on 8 August 2021. Assuming that the lack of activity was indicative of there being no chicks hatched, this potentially places hatching between 9 and 11 August 2021. This suggests a nominal fledging date of 6 to 8 September 2021 (28-30 days post-hatch), with the latest date being 9 September 2021 (Barbara Stewart, pers. comm.).
